## EN 124-1 Pit Cover Testing

### 24" x 24" Pit Cover

BGSE Group

JID 19-00074

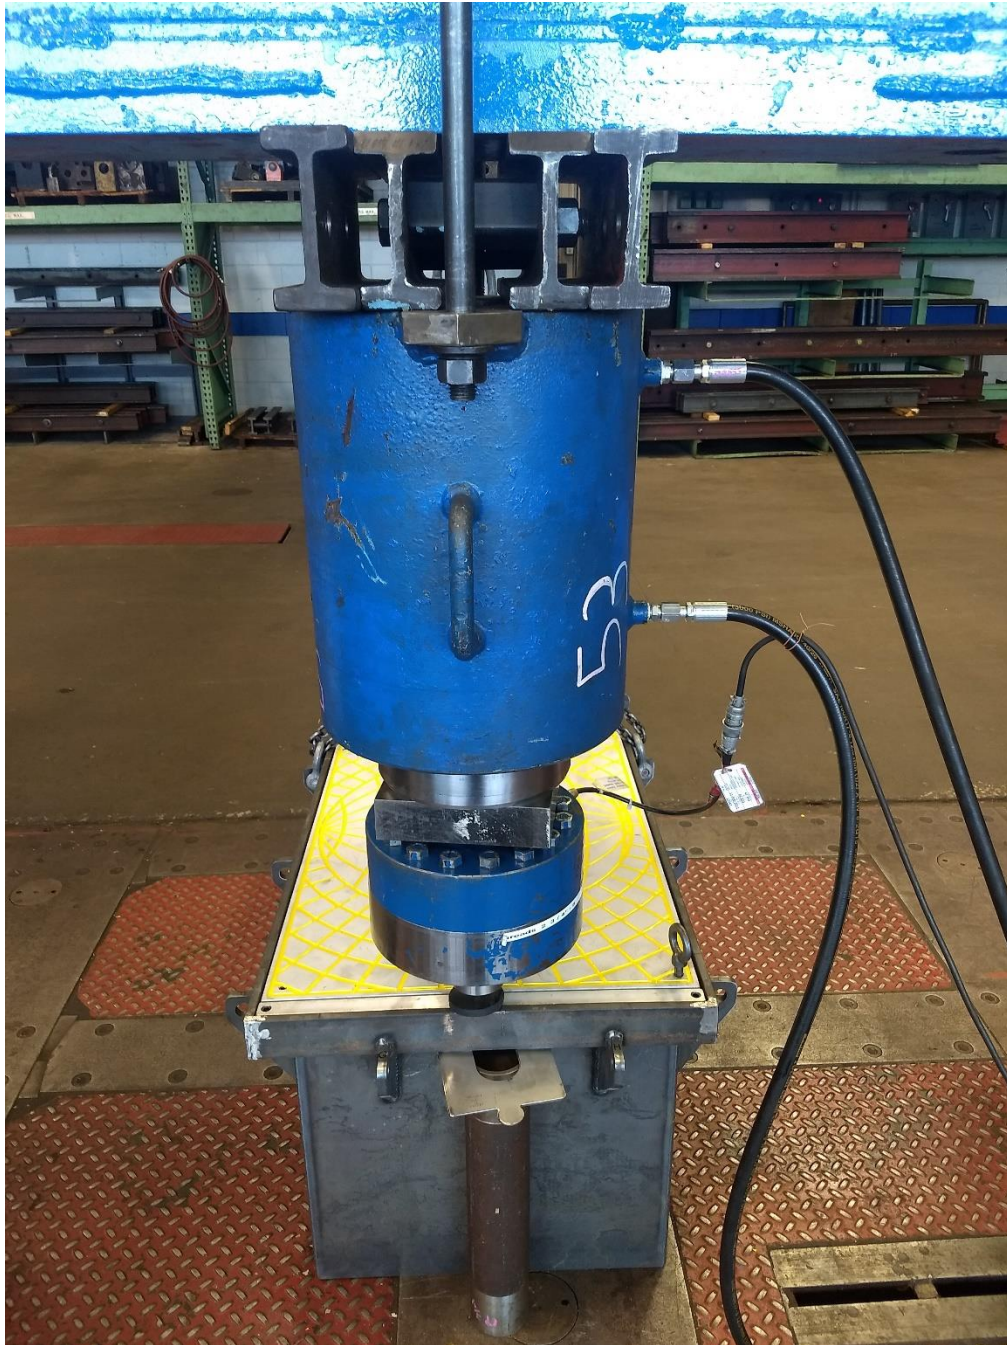
**Photograph 1 Tilt Testing Setup**

8.4.5 Compatibility of seatings. Perform tilt test per Annex D.

Apply load from 0 to 50 kN (11,240 lbs) at 1-5 kN/s (225 – 1124 lbs/sec) 3 times in center of each side with 75 mm dia test block and 10 mm thick rubber sheet. Record tilting height on opposite side. Temperature must be between 59 and 95 deg F.

8.4.5 Compatibility of Seatings. The tilt test demonstrated a maximum tilting height of 2 mm. This meets the requirement of  $0.5 \times$  depth of insertion or 25 mm. It should be noted that no pins or attachment hardware was in place for this test.

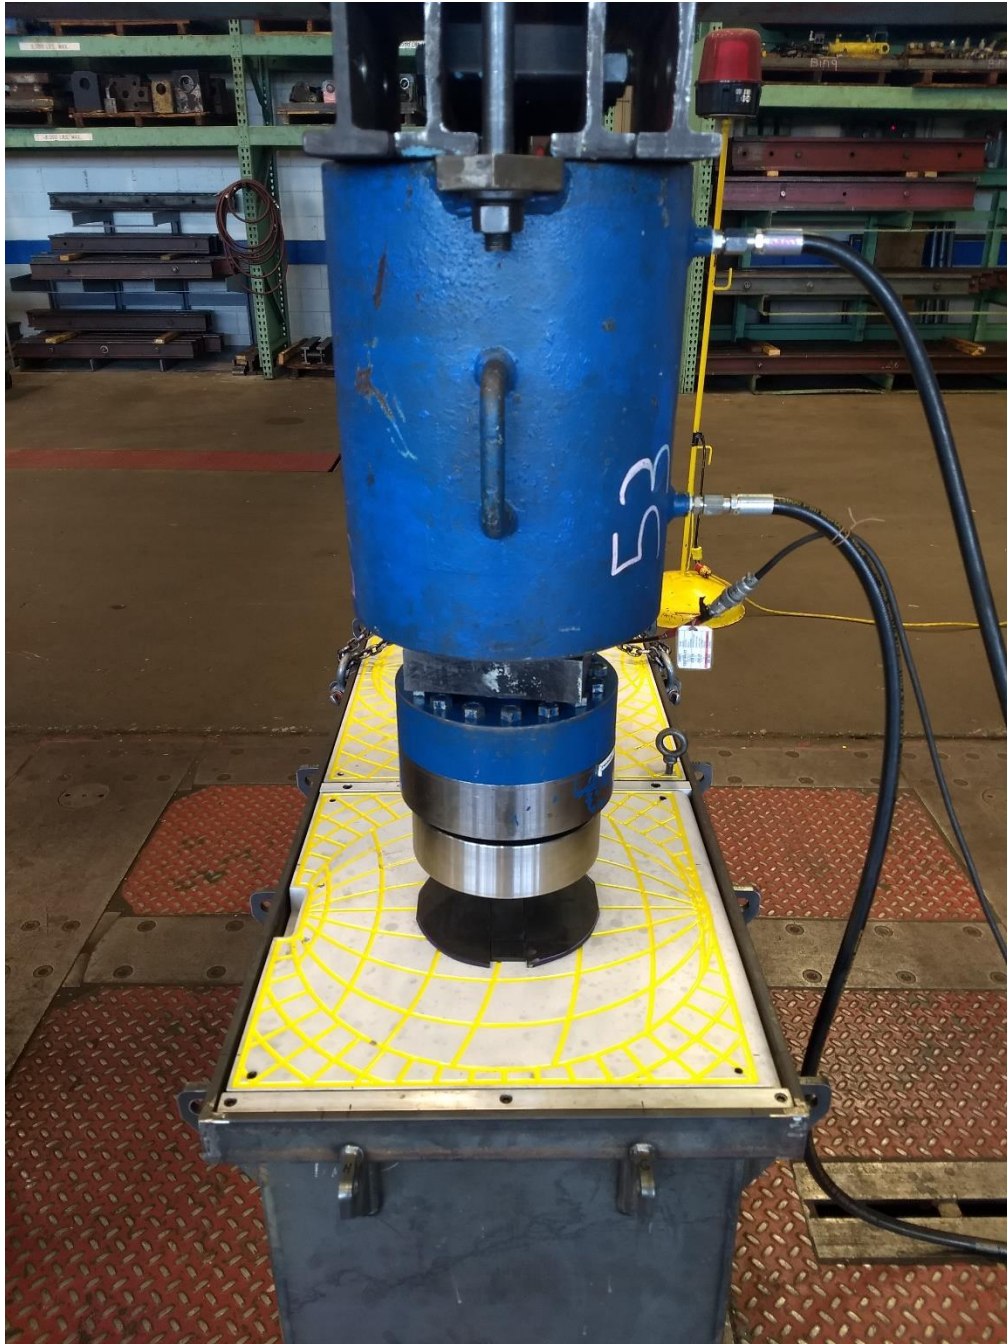
**Photograph 2 Load Test Setup**

8.2 Permanent set. Perform permanent set test per Annex A.

Apply 600 kN (134,885 lbs) vertical load 5 times at a rate of 1-5 kN/s. Measure the permanent set to an accuracy of 0.1 mm (.004”).

8.3 Load bearing capacity. Perform load test per Annex B.

Apply 900 kN (202,328 lbs) vertical load.

8.2 After the permanent set test there was less than 0.1 mm permanent set. This meets the requirement of  $< 1.1$  mm.

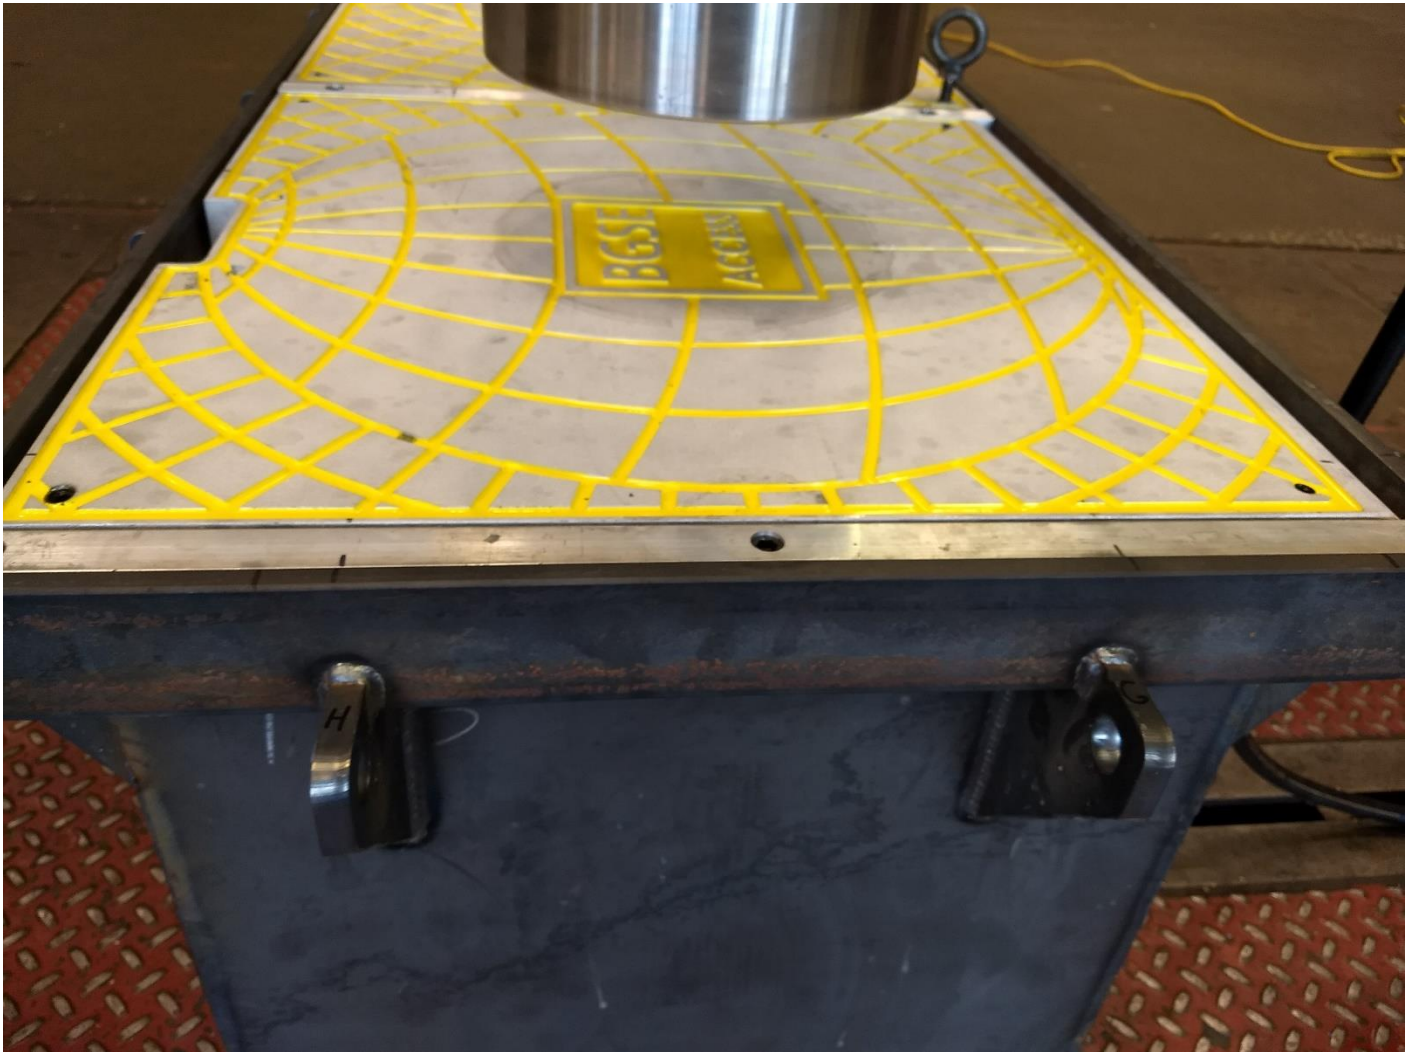
**Photograph 3 Cover and Frame Post Test**

8.3 The load bearing capacity test demonstrated the capability to hold a load of 900 kN. After the test there was no visible damage and no visible permanent set. The condition of the cover after removal of the test load is shown in Photograph 3.
