EN 124-1 Pit Cover Testing

36" x 36" Pit Cover, Rev 1

BGSE Group

JID 19-00074

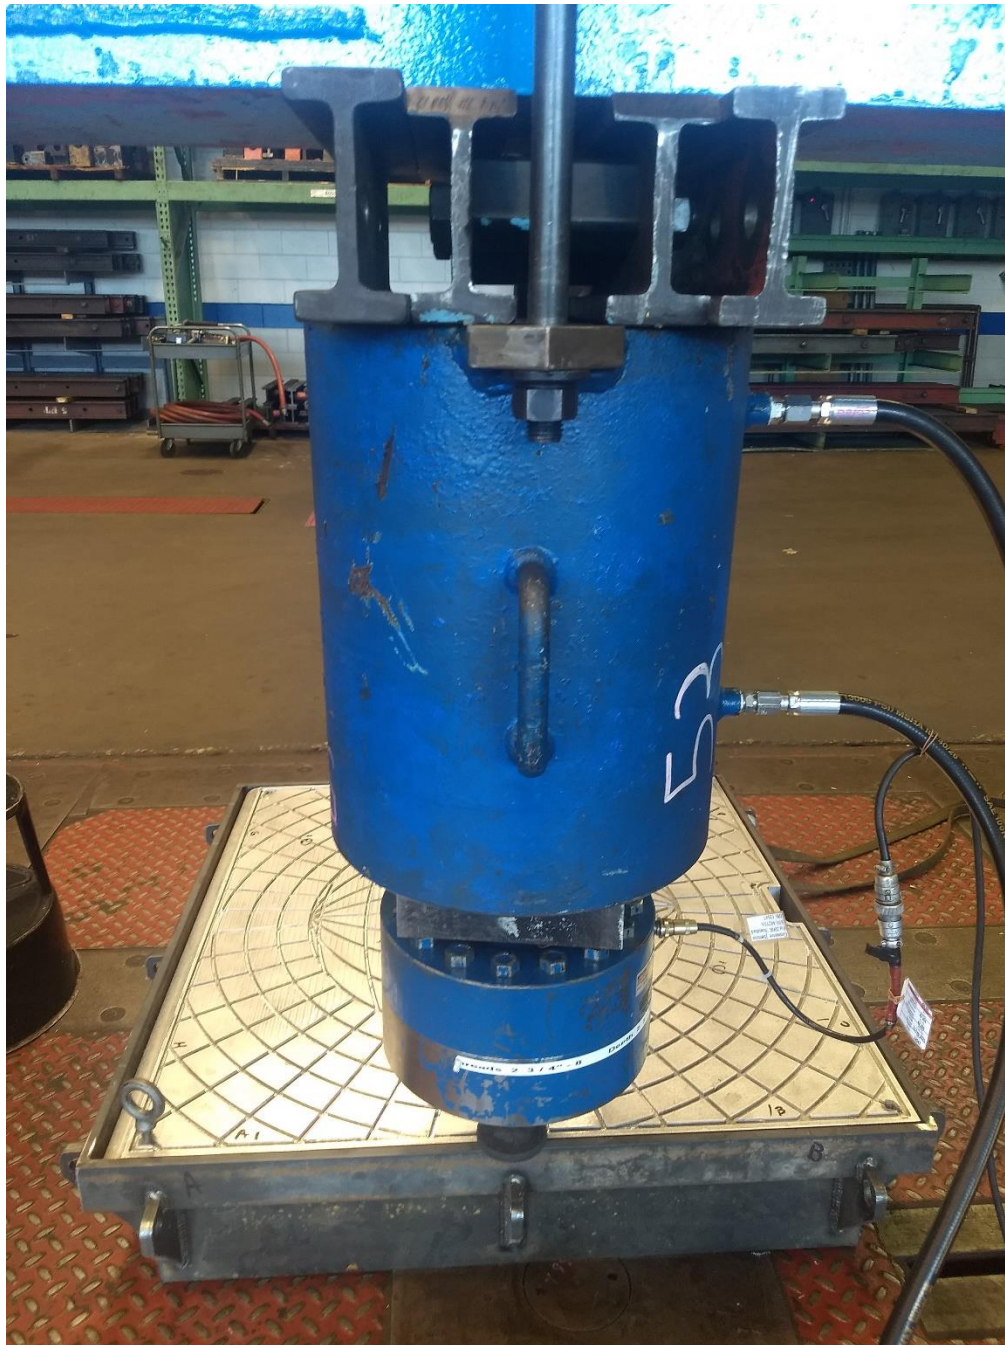
**Photograph 1 Tilt Testing Setup**

8.4.5 Compatibility of seatings. Perform tilt test per Annex D.

Apply load from 0 to 50 kN (11,240 lbs) at 1-5 kN/s (225 – 1124 lbs/sec) 3 times in center of each side with 75 mm dia test block and 10 mm thick rubber sheet. Record tilting height on opposite side. Temperature must be between 59 and 95 deg F.

8.4.5 Compatibility of Seatings. The tilt test demonstrated a maximum tilting height of 0.8 mm. This meets the requirement of $0.5 \times$ depth of insertion or 25 mm. It should be noted that no pins or attachment hardware was in place for this test.

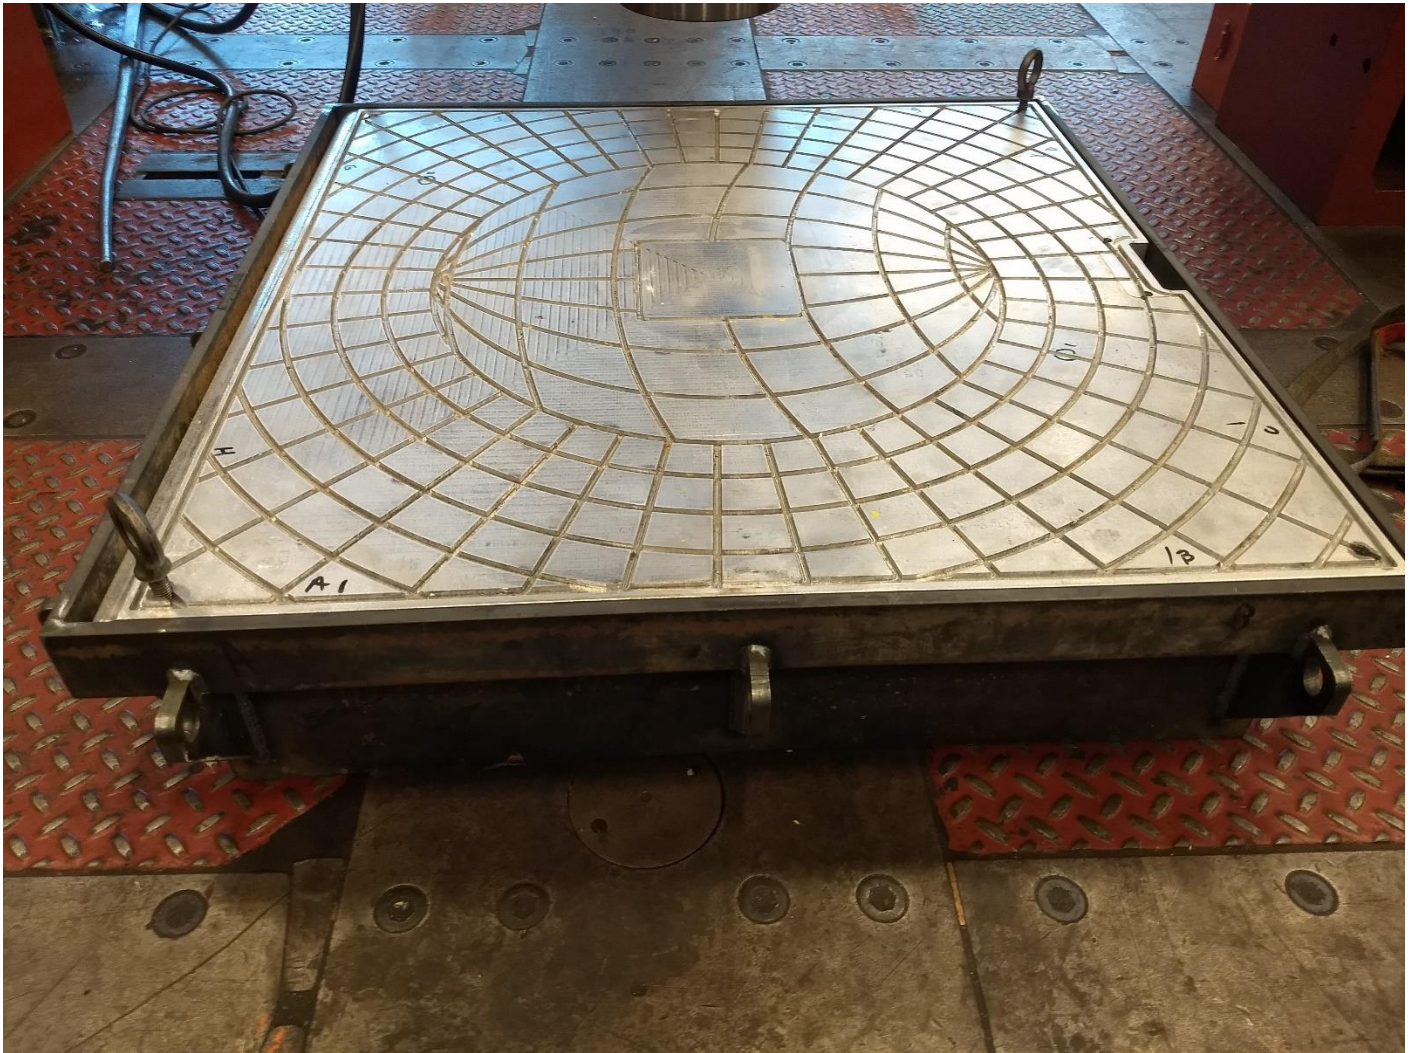
Photograph 3 Cover and Frame Post Test

8.3 The load bearing capacity test demonstrated the capability to hold a load of 900 kN. After the test there was no visible damage. The condition of the cover after removal of the test load is shown in Photograph 3.
